BENDING PROPERTIES OF WOOD I-JOIST MADE WITH PINUS (*PINUS SP.*) AND CURUPIXÁ (*MICROPHOLIS VENULOSA*) FLANGES

This study aimed to evaluate the bending properties of I-joist made with medium density fiber (MDF) panel web and flanges of *Pinus* sp., curupixá (*Micropholis velunosa*) and combined flanges. The tests comprised 21 beams, being 7 for each group. The join between flange and web was provided by single component polyurethane (PU) structural adhesive in 200 g m⁻². The beams were tested to determine the modulus of rupture (f_m) and modulus of elasticity (E_M) in static bending. The pinus beams showed a mean value of 6638 N mm⁻² for E_M and 19.6 N mm⁻² for f_m , while curupixá beams showed values of 12190 N mm⁻² and 22.6 N mm⁻², respectively. The E_M and f_m values for composite beams were in between the figures described above, i.e. 9027 N/mm² and 20.5 N/mm². There was a significant difference for E_M among the beams with pinus flanges and curupixá flange. However, the f_m was not affected by the type of flange used. It was observed that at least 1/3 of the failure occurred between the flanges and the web joint, especially in beams made with curupixá, which prevented the bea

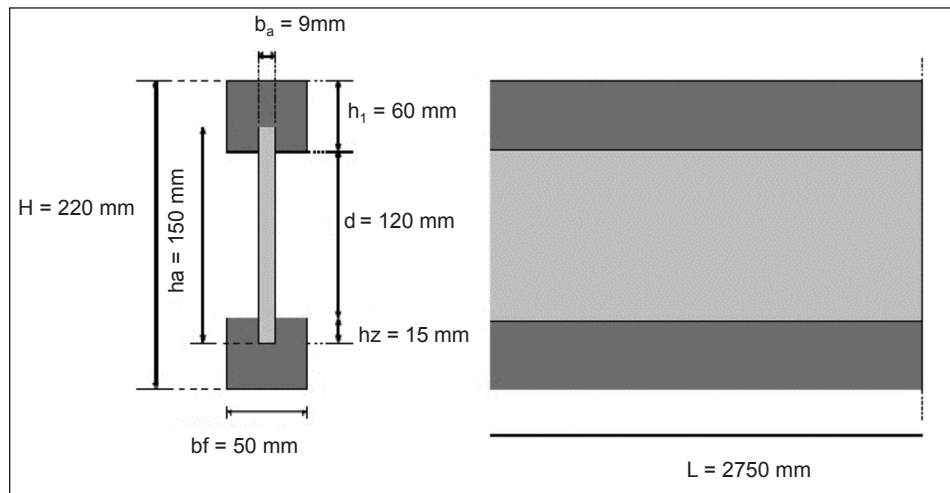
Figure 1 I-Joist nominal dimensions and its structural elements

The edges of MDF boards were sanded to activate bonding surface. The area of each glue line was 0.11 m². A total of 22 g of PU adhesive was weighed using an electronic scale with 0.01 g resolution. The adhesive was spread with a wooden stick until homogenous. After adhesive spreading, the flanges were fitted in the web and pressed using four clips, two at the edges and two at the central portion. The pressing has a load of 4000 kg force for a duration of 5 hours. Beam dimensions are shown in Figure 1.

To calculate the moment of inertia, 21 beams were measured. As the difference between them was minimal, the beam nominal dimensions were considered (Figure 1), thus, the moment of inertia was calculated as 3.84 × 10⁷ mm⁴ for all beams.

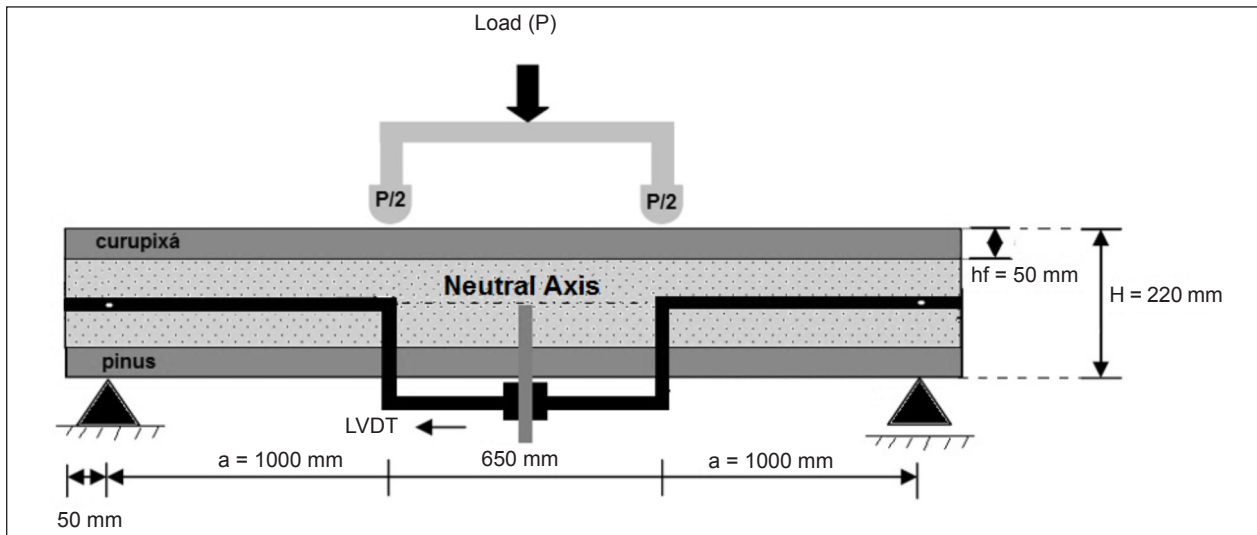
Figure 2 4-point static bending testing schedule

First, a metal bar was fixed by screw at 50 mm from the beam edge, at neutral beam line without any contact, to avoid interference with deflection measurement by LVDT. The bar extends across the beam requiring an apparent modulus of elasticity, since its non-deformation was considered in terms of shearing. The beams were supported by parts with bearings to avoid crushing effect. A part, with two separated actuators at 650 mm and positioned at 1000 mm from each beam edge, was utilised in load application. Thus the relation between the beam height and the distance between support and loading application was 1:4.54, characterising the beam as short (ASTM 2013). The test schedule is represented in Figure 2. All tests were performed between 10 and 20 minutes at 5.98 mm min⁻¹ speed (ASTM 2014).

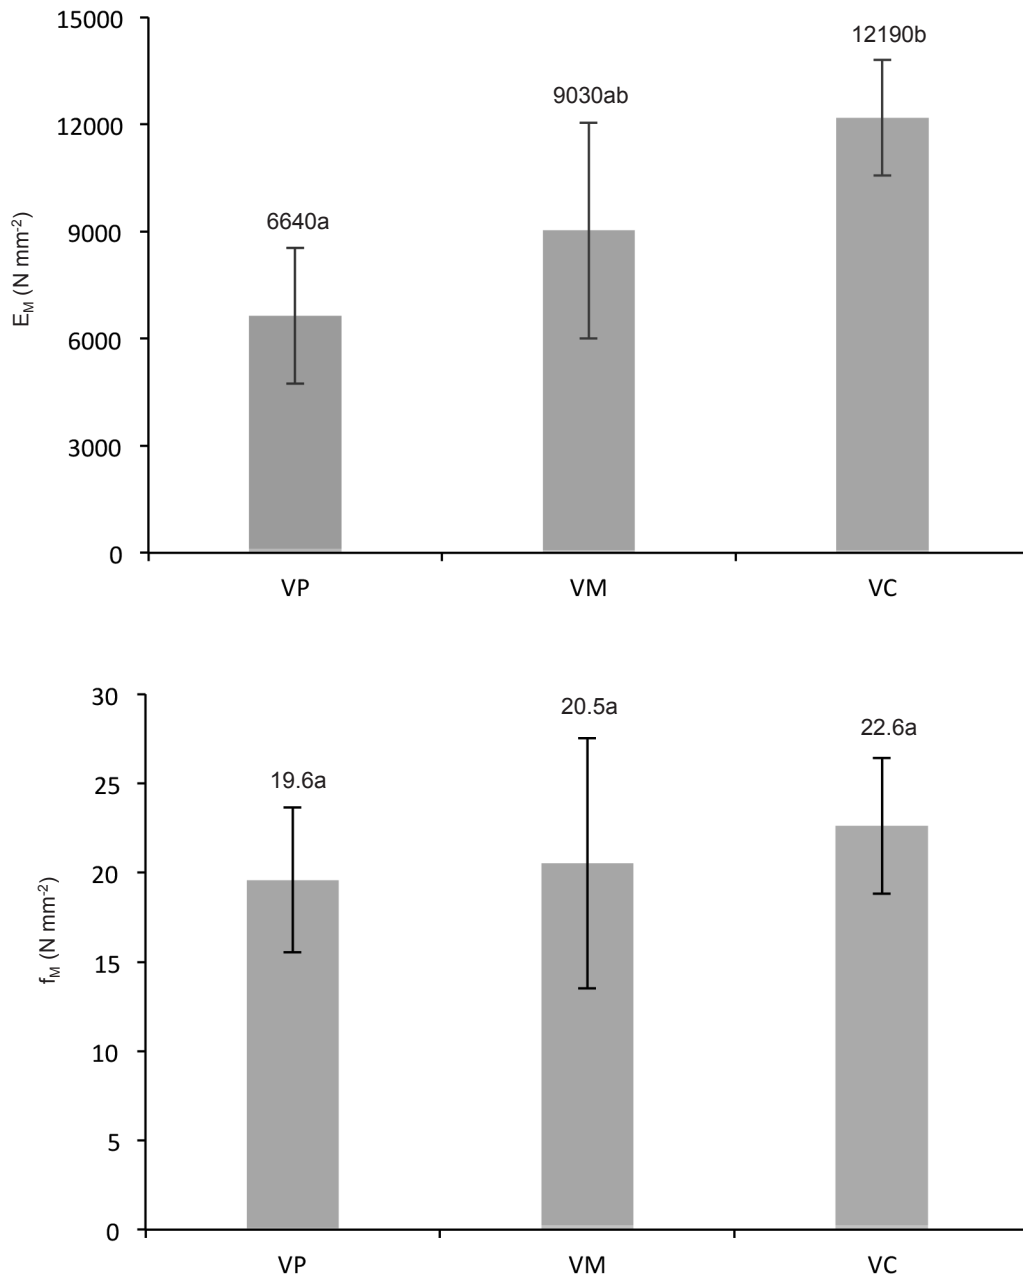
Figure 4 Modulus of elasticity and modulus of rupture of the tested wood I-joists; VP = less rigid treatment, VM = two species combination, VC = more rigid treatment

Figure 4 shows the bending properties of all beams, i.e. modulus of elasticity, maximum bending moment, rupture load and modulus of rupture. Two statistically discrepant data (VC4 and VP6) were removed for statistical

purposes. The variance analysis indicated significant differences among treatments for modulus of elasticity, separating them into two groups. The first group indicated non-significant difference between pinus beams and composite beams and the second group indicated non-significant difference between curupixá beams and composite beams. Thus, there is a clear

statistical difference in modulus of elasticity between pinus beams and curupixá beams. There was no statistical difference between the three treatments for the modulus of rupture, thus the species had no influence on beams bending strength (Figure 4).

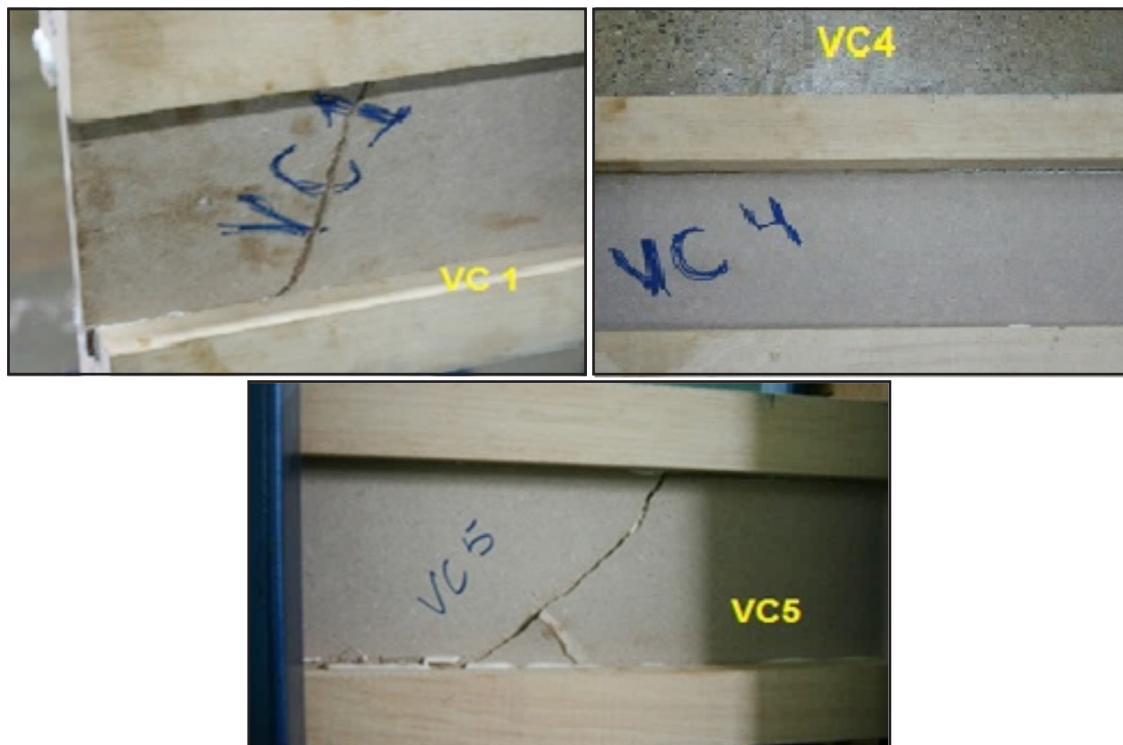
Figure 5 Rupture mode (ZW) observed for curupixá flanged wood I-joist

According to ASTM (2013) classification, failures occurred in I-beams with curupixá flanges were typical shearing and glue line failures. The VC1, VC2 and VC5 beams showed typical shearing failures, classified according to the standard as rupture mode (ZW). This classification is performed to shearing failure in the web at angle next to 45°, not necessarily passing through a web-web join. Such a situation was non-existence in this study since all the beams were made with web in a single piece. The VC3, VC4, VC6 and VC7 beams had failed in the glue line, classified as no glue transfer (NGT) by the standard. Although there was proper spreading of the adhesive, the transfer between the surfaces did not occur. The non-transfer may be due to insufficient adhesive as recommended by the manufacturer for the species. The flange/web joint sliding generated a typical bending failure except in VC4 (Figure 5).

The failures of I-beams composite had five different classifications according to ASTM (2013) (Figure 5). The VM1 and VM4 beams were broken due to compression failure by bending the upper flanges, with lateral buckling of the part, indicating deficiency in the amount of side supports on the beam, classified as flange buckling failure (FCB). In the beams, essays were utilised for side supports. The VM3 and VM6 beams showed failure classified as FT, which according to the standard are failures by tension. In VM3, the failure was caused by the presence node in the lower flange, observed before the test,

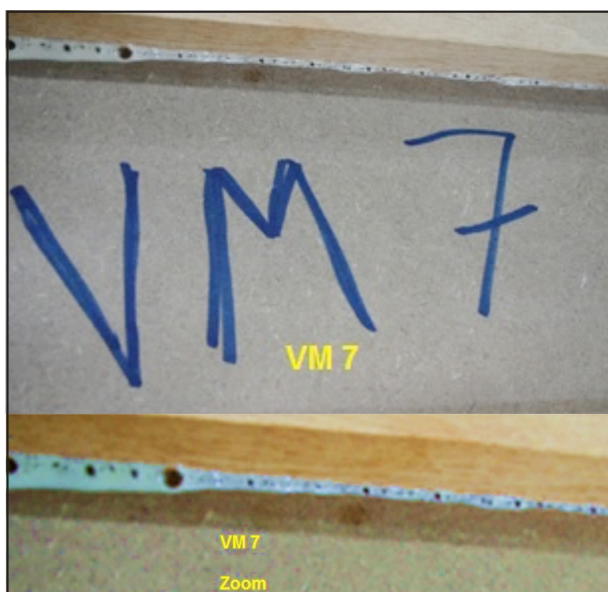
Figure 6 Evidence of glue-line shear of curupixá flanged wood I-joists

resulting in brittle rupture of the beam, classified as prior to test (PTT). In VM6, the failure by tension was caused by glue line failure of the upper flange, classified as NGT. The VM2 beam failure was caused by web compression failure, classified as flange failure in flexural compression (FC). The VM6 beam was the only one that failed by shearing due to vertically web failure being classified as ZJ. The VM7 beam had no flanges or web failures and failure only happened on the glue line, classified as NGT, featuring an adhesive transfer failure to the surface (Figure 6).
